AVIATION INVESTIGATION REPORT

A01W0304

CONTROLLED FLIGHT INTO TERRAIN

CESSNA 172N C-GGFT

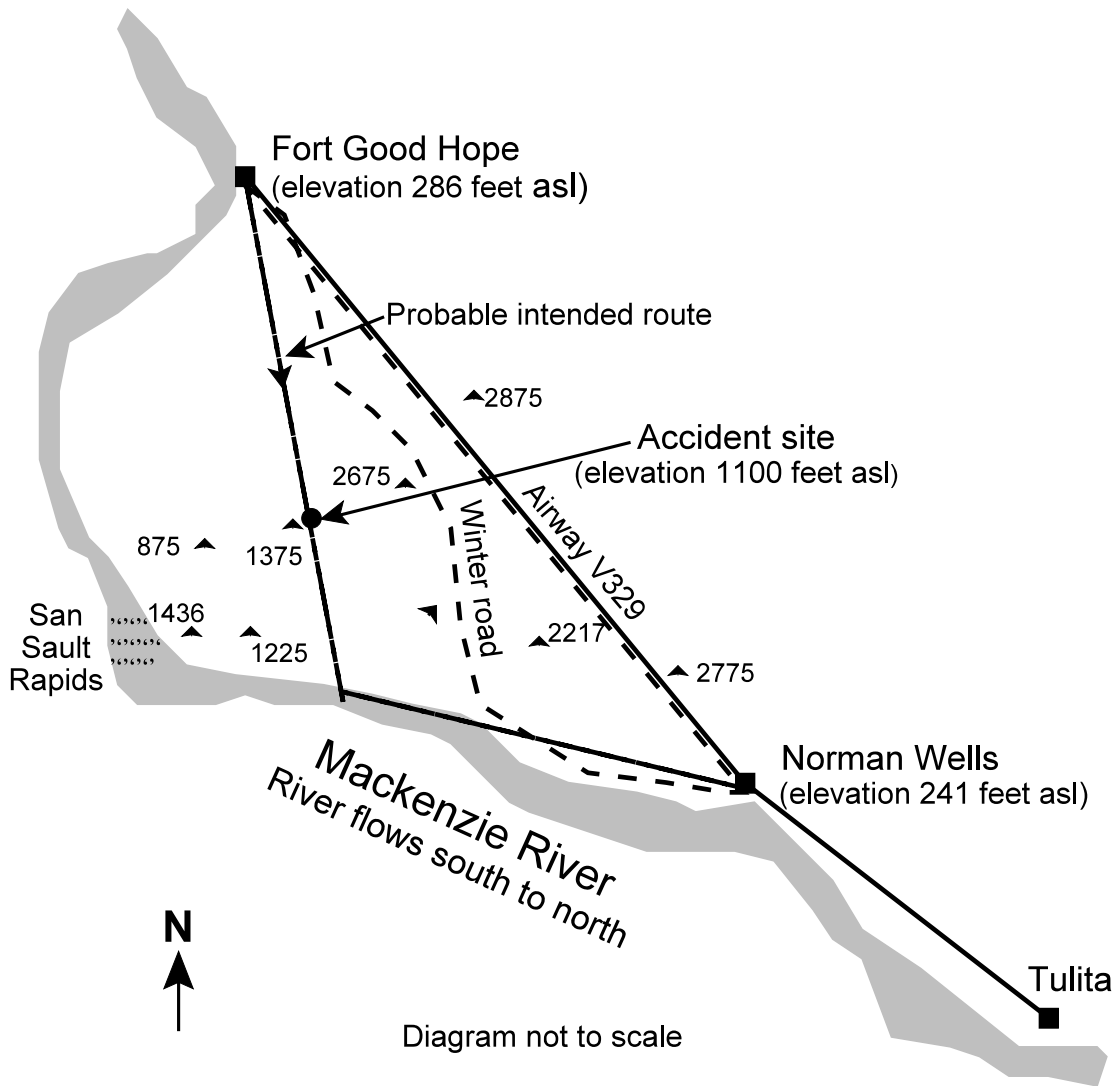
Appendix A - Diagram of Occurrence Area

The location of the accident site suggests that the pilot had flown directly south from Fort Good Hope to intercept the river valley upstream of Sans Sault Rapids, bypassing the rapids. Based on information from weather observations, the pilot's own experience and discussion, and other pilots in the area, it is probable that the pilot encountered icing conditions and reduced visibility in snow showers or cloud. Since the wreckage remained intact and three of the occupants survived the direct impact with non-life-threatening injuries, the pilot was most likely flying at low airspeed. Perhaps he was intentionally flying slow and low in an attempt to maintain or regain visual reference with the terrain. The cruise flight configuration and the straight and level aircraft attitude at impact are consistent with a controlled flight into terrain accident.
